EPRI-NASA Cooperative Project on Stress Corrosion Cracking of Zircalloys

NP-717
Research Project 455-1

Final Report, March 1978

EPRI NP-717
Project 455-1
Final Report
March 1978

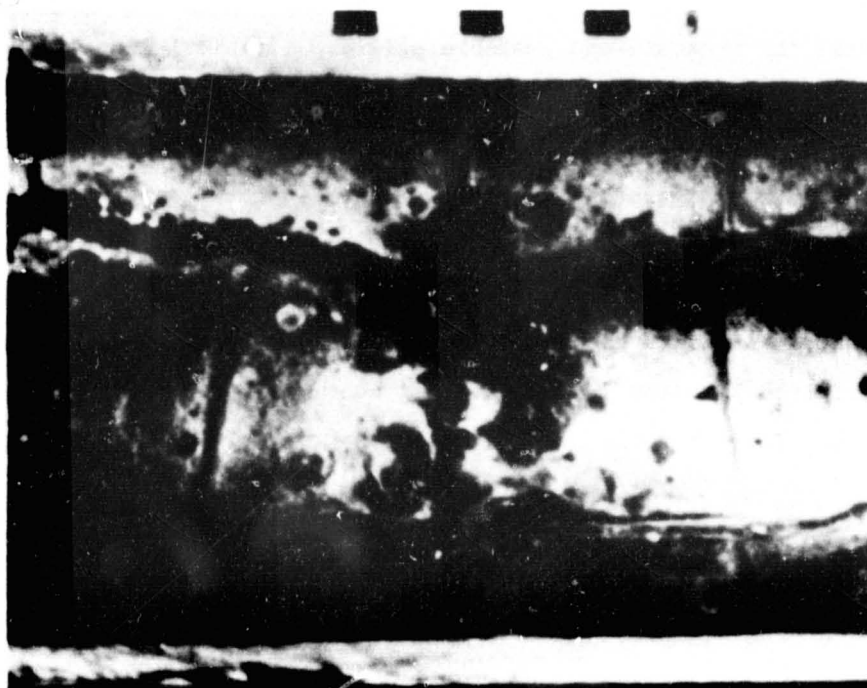
SA-4197-310

The general nature of the deposits on the inside of the cladding can be seen in the optical photograph, Figure 2-1, which shows the inside surface of the cladding after the rod had been slit open and the fuel removed. The deposits were of three types: (a) sharply defined linear stripes, which occurred opposite cracks in the fuel; (b) concentrations of more massive deposits at the locations of pellet-pellet interfaces; and (c) circular, mound-like deposits at random locations. In addition, there were occasional chips of fuel that strongly adhered to the cladding.

FIGURE 2-1 OPTICAL PHOTOGRAPH OF THE INNER SURFACE OF A SECTION OF CLADDING FROM A MAINE YANKEE CORE I ROD (JCN 196)

Width of photo corresponded to 1.5 cm of cladding length. The vertical band of deposits occurred at a pellet interface. The thin line deposits were opposite fuel cracks.

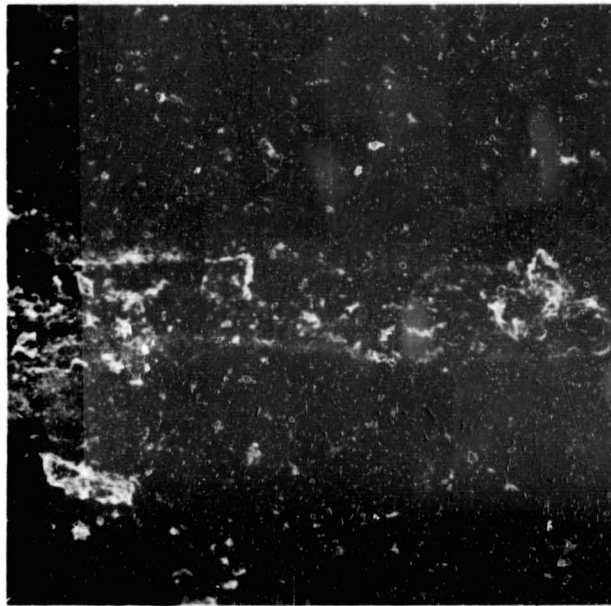
SA-4197-311

The SEM examination was concentrated on the distinctive features seen in Figure 2-1 so as to reveal their nature and probable origin. A typical linear deposit (type a) is shown in greater detail in Figure 2-2. The stripe, which is horizontal in the figure, consists of two parallel gray bands about 0.1 mm apart. Between the two bands there seems to be a concentration of particles of random size and shape.

The areas above and below the band in Figure 2-2 represented the majority of the cladding surface. The dark regions showed only Zr and had a smooth, wavy surface typical of oxidized Zircaloy. The particles contained U and Cs and were apparently particles of UO_2 fuel that had reacted with some Cs.

FIGURE 2-2 SEM PHOTOGRAPH OF A LINEAR DEPOSIT
Width of photo = 0.5 mm.

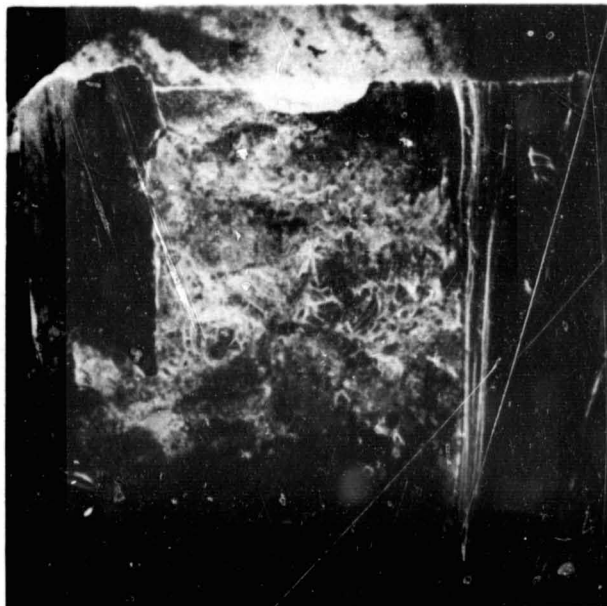
A piece of fuel adhering to the cladding is shown in Figure 2-4. The fuel was distinguishable by its grain size ($\sim 2 \mu\text{m}$) and structure; analysis showed only U. Fuel chips were apparently cemented to the cladding by some of the Cs-U ceramic material, which was observed at the base of the chip. Near the base of the ceramic material, as well as near the base of the circular mounds, small bands of nodules, similar to those in the stripes, were often observed.

FIGURE 2-4 SEM PHOTOGRAPH OF A PELLET INTERFACE DEPOSIT
Width of photo = 5 mm.

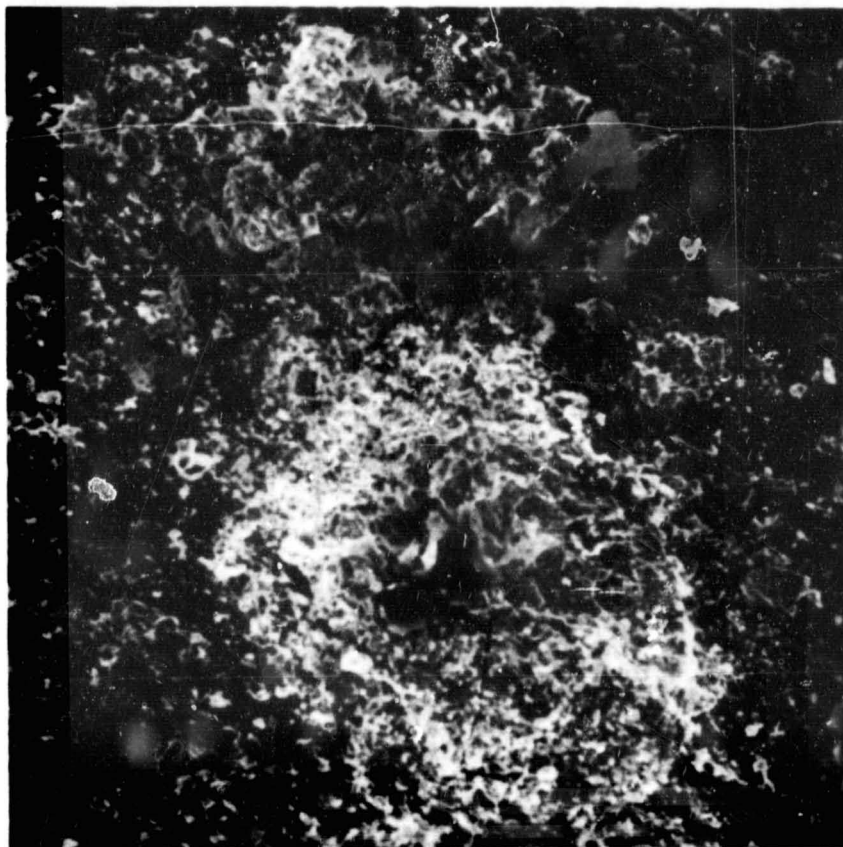
The deposits found opposite pellet-pellet interfaces (type b) generally contained larger amounts of material and were much more radioactive than the linear deposits found opposite fuel cracks. As noted above, intense peaks of Cs^{137} activity were observed at pellet-pellet interfaces in gamma scans of the cladding. A massive deposit of the type found opposite pellet-pellet interfaces is shown in Figure 2-4 and in greater detail in Figure 2-5. The material looks like a brittle ceramic substance that was molten at some stage and had cracked during solidification. SEM analyses showed only U and Cs in proportions that varied through the thickness of the deposit. The Cs:U ratio was largest in the material adjacent to the cladding and smallest in the material nearest the fuel. A transverse metallographic section of one massive deposit was prepared that showed the deposit to consist of a duplex layer. Electron microprobe analysis of the section showed that the layer nearest the cladding contained uranium and cesium while the layer nearest the fuel contained principally uranium with some cesium and other fission products. The ceramic appearance of the material suggested it was an oxide.

FIGURE 2-5 SEM PHOTOGRAPH OF INTERFACE DEPOSIT MATERIAL
Width of photo = 220 μm .

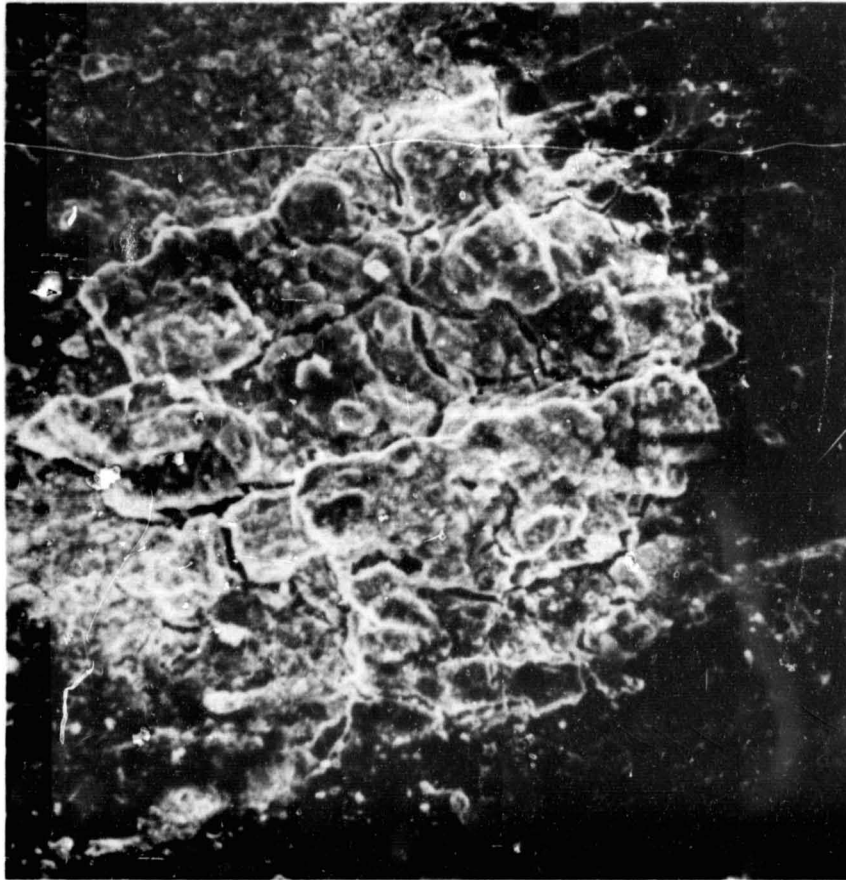
The small circular mound deposit in the lower right corner of Figure 2-4 is shown in greater detail in Figure 2-6. It was representative of the type c deposits observed to occur randomly over the surface. Another example is shown in Figure 2-7. Those mounds were found to consist of essentially the same material as the massive deposits, showing the same brittle fracture and duplex structure, with greater cesium concentrations next to the cladding.

FIGURE 2-6 SEM PHOTOGRAPH OF CIRCULAR MOUND DEPOSIT FROM LOWER RIGHT CORNER OF SAMPLE IN FIGURE 2-4

Width of photo = 270 μm .

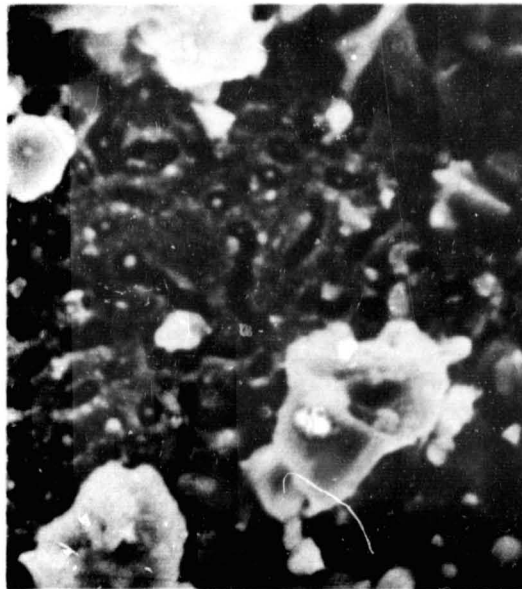
FIGURE 2-7 SEM PHOTOGRAPH OF ANOTHER EXAMPLE OF A CIRCULAR
MOUND DEPOSIT

Width of photo = 300 μm .

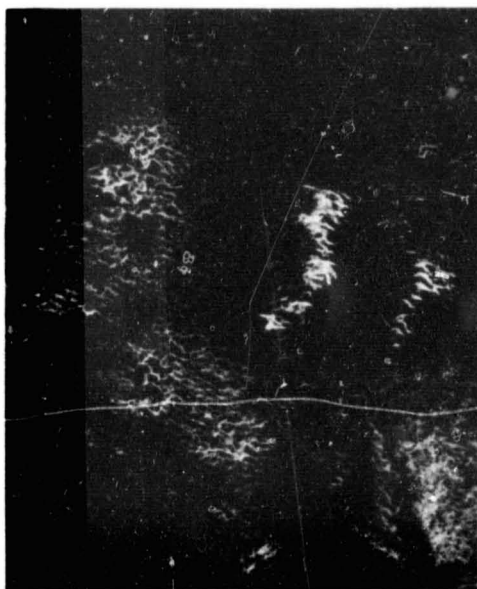
SEM examination showed that the inner surfaces of the cladding were relatively clean and free of deposits. Figure 2-9 shows the general appearance. The majority of the surface was covered with a dark gray zirconium oxide. There were occasional lighter gray patches of various sizes and shapes, some of which were several millimeters in longest dimension, where apparently fuel pellets or pieces of fuel had pressed against the cladding. Also, the surface was sprinkled with small crystals. None of the prominent features found on the Maine Yankee cladding (stripes opposite fuel cracks, pellet-pellet interface deposits, or circular mounds) were observed on these samples of H.B. Robinson cladding. Also, no fission products were detected in any of the features or particles on the surface except for an occasional trace of cesium. The only elements generally observed were uranium, in the light grey patches and small particles, and of course zirconium. (In one small spot a stain containing iron was noted, which may have been formed after the rod was opened. In another spot a particle presumed to be alumina was found embedded in the surface.)

FIGURE 2-9 SEM PHOTOGRAPH OF INNER SURFACE OF CLADDING FROM
H.B. ROBINSON ROD

Width of photo = 8 mm.

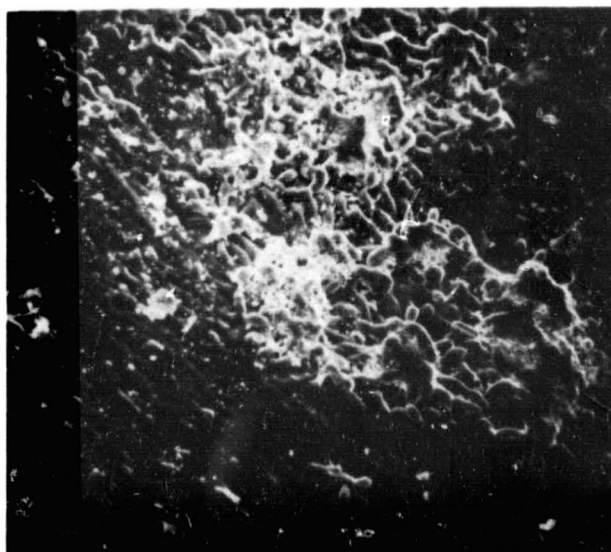
Figure 2-10 shows one of the gray patches in greater detail. The light gray regions near the lower right and upper left sections of the photo contained mainly U with some Zr. They were apparently areas where fuel had pressed against the cladding, had reacted with it, and then been detached from it, leaving some UO_2 behind. The dark areas with white ridges contained mainly Zr with some U. They were apparently regions of enhanced oxidation of the Zircaloy, possibly due to a higher local temperature where the fuel pressed against the cladding. The upper part of the photo shows the smooth, oxidized Zircaloy surface that is characteristic of the large majority of the cladding surface.

FIGURE 2-10 SEM PHOTOGRAPH OF AN AREA
OF FUEL-CLADDING CONTACT

Width of photo = 330 μm .

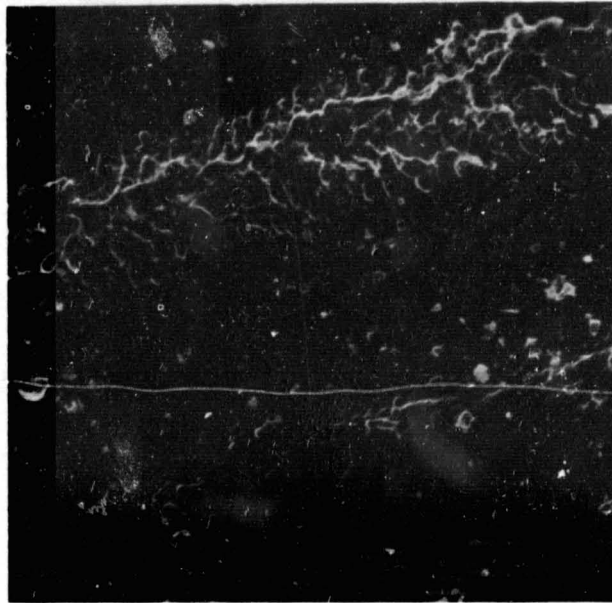
The type of light gray surface seen just to the lower left center of Figure 2-10 is shown at higher magnification in Figure 2-11. The small, light crystals contained mainly U and were apparently grains of UO_2 fuel. The worm-like material was ZrO_2 containing variable proportions of UO_2 . The detailed structure of those worm-like features indicates they were caused by the reaction of UO_2 with ZrO_2 . The UO_2 apparently became incorporated into the ZrO_2 which resulted in a faster local oxidation.

FIGURE 2-11 SEM PHOTOGRAPH OF A GRAY PATCH

Width of photo = 180 μm .

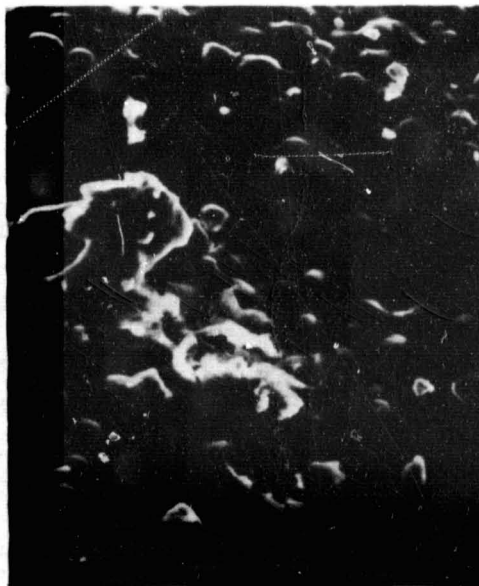
The horizontal white line in Figure 2-9 is shown at higher magnification in Figure 2-12. It consisted of the worm-like material containing U as well as Zr. Presumably that structure was originally a scratch on the cladding surface made during fuel rod loading. The scratched area apparently oxidized somewhat more rapidly than the unscratched areas due to the interaction of UO_2 particles with the fresher Zircaloy surface.

FIGURE 2-12 SEM PHOTOGRAPH OF DETAIL OF SCRATCHED REGION
Width of photo = 200 μm .

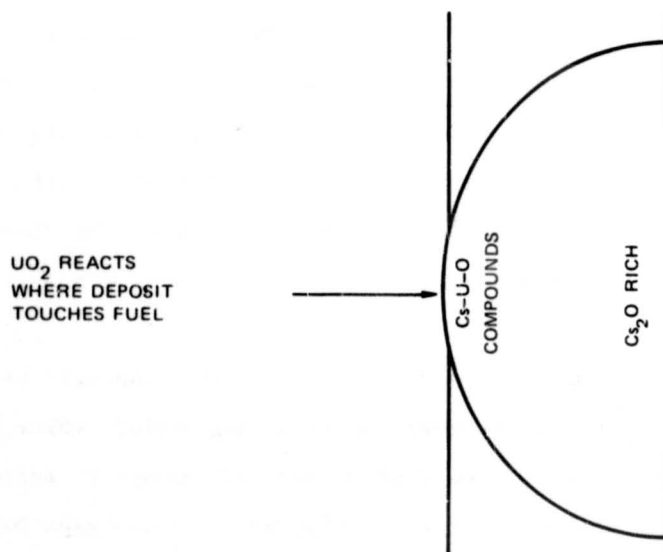
A model for the formation of the more massive Cs-U ceramic deposits must consider the transport of Cs, O, and U. We propose the following model, which is illustrated in Figure 2-16. When the center of the fuel became hot enough to release fission products, gaseous Cs_2O was evolved. It was transported to the gaps between pellets, and then to the cladding at pellet interfaces, where it deposited to form type b deposits. The deposit, according to this model, was originally rich in Cs_2O , but at some time it came in contact with the fuel. The Cs_2O melted and dissolved some UO_2 to form a higher melting solid that solidified into the observed deposit.

(a) Cs₂O VAPOR RELEASED FROM HOT CENTRAL FUEL TRAVELS ALONG FUEL CRACKS OR INTERCONNECTED POROSITY AND FINALLY DEPOSITS ON CLADDING

(b) WHEN FUEL TOUCHES DEPOSIT, THE Cs₂O MELTS AND REACTS WITH UO₂

FIGURE 2-16 SCHEMATIC DIAGRAM FOR FORMATION OF CERAMIC DEPOSITS

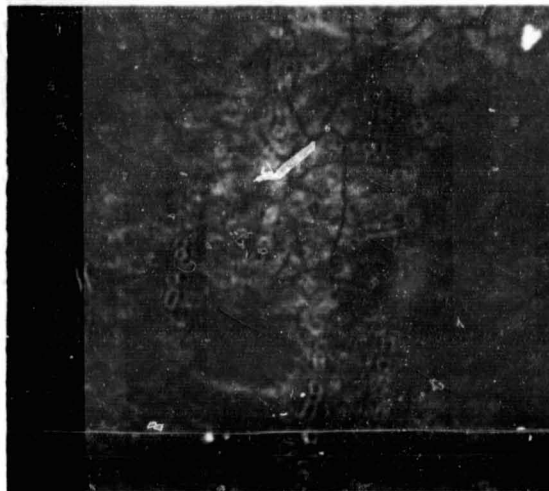
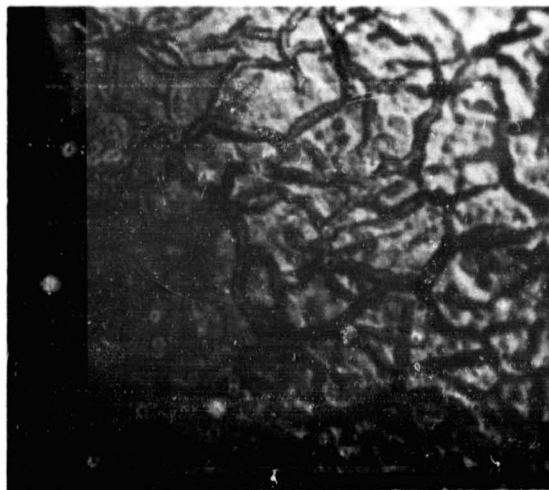
(a) BEFORE Ar-ION MILLING

(b) AFTER Ar-ION MILLING FOR 2.8 HR

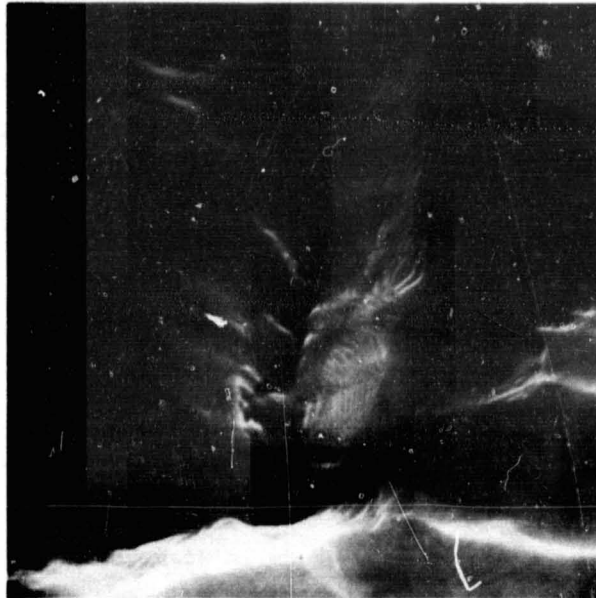
FIGURE 4-4 TYPICAL SMALL CRACKS IN PREOXIDIZED ZIRCALOY-4 SHEET

Figures 4-4 and 4-5 show typical examples of the two types of cracks. Figures 4-6 shows an example of the larger type of crack in which the cracks in the metal followed oxide cracks and radiated out from a region containing elements other than Zr. Another such region is shown in Figure 4-7. The granular lumps in Figure 4-7 were typical of regions containing higher-than-normal concentrations of alloying additives and impurities. Similar features were also observed in samples that had not been exposed to I_2 , but there were no cracks associated with those features

(a) 50-kg LOAD, 40 Pa I_2 , 200 MIN, 570 K
Photograph width = 0.9 μm .

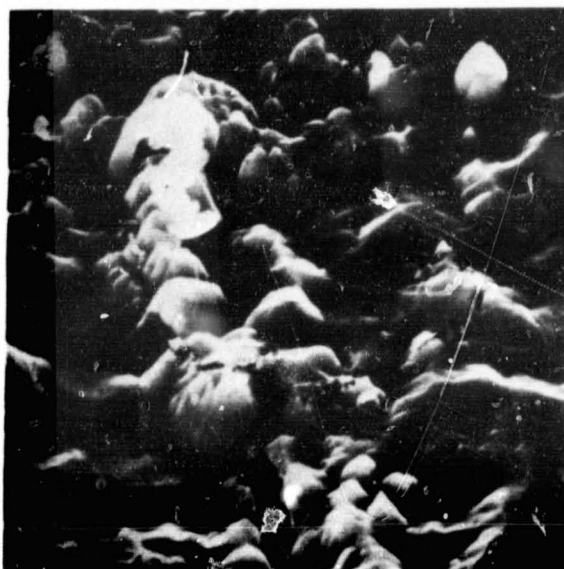
FIGURE 4-5 LARGE CRACK ASSOCIATED WITH IMPURITIES — PREOXIDIZED ZIRCALLOY-4 SHEET, 50-kg LOAD, 40 Pa I_2 , 20 MIN, 570 K

Light-gray granular lumps contained several percent Si, Fe, Cr, and some Al. Dark-gray matrix was only Zr. Width of photograph = 20 μm .

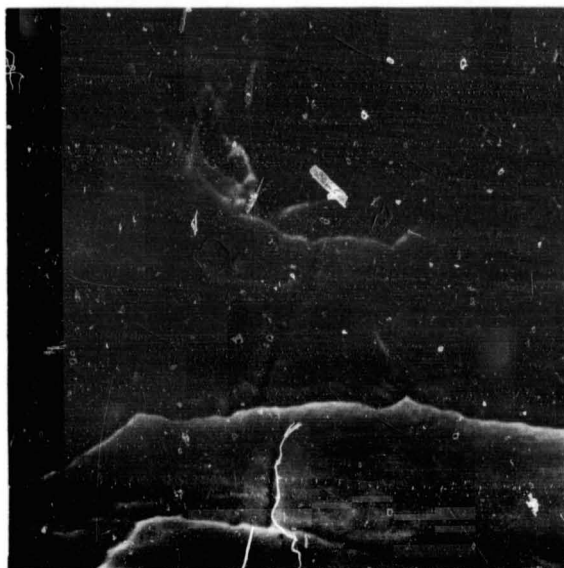
FIGURE 4-6 LARGE CRACK ASSOCIATED WITH IMPURITIES — PREOXIDIZED ZIRCALLOY-4 SHEET, 50-kg LOAD, 40 Pa I_2 , 60 MIN, 570 K

Ridge contained several percent Si, Al, and some Fe, Cr. Some oxide layer still present on surface (after 2 Hr. ion milling). Width of photograph = 20 μm .

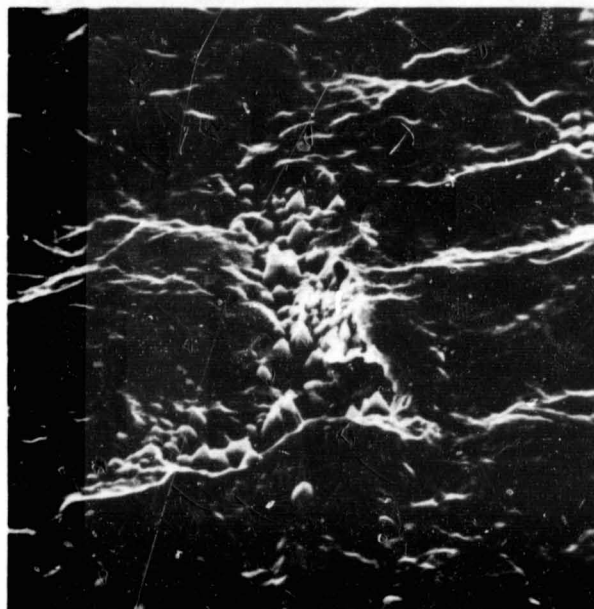
FIGURE 4-7 LARGE CRACK ASSOCIATED WITH IMPURITIES — PREOXIDIZED ZIRCALOY-4 SHEET, 40-kg LOAD, 50 Pa I_2 , 30 MIN, 570 K

Light-gray granular lumps associated with crack contained several percent Ti, Fe, Cr. Dark-gray matrix contained only Zr. Width of photograph = 100 μ m.

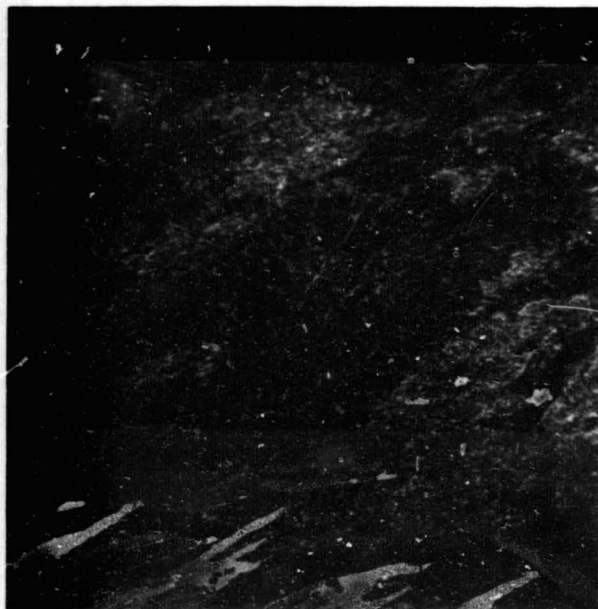
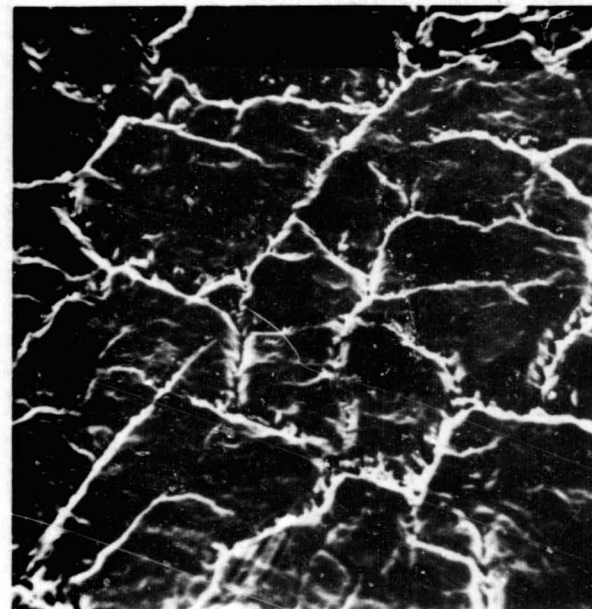
Grubb (4-4, 4-5) observed that Cd can cause embrittlement of Zircalloys; accordingly, we made a few tests in which pieces of Cd were placed on the surface of samples in an argon gas stream. The behavior in these tests was indistinguishable from that observed in tests made with Ar alone. In other tests, a stick of Cd was rubbed against the surfaces of samples (either preoxidized or as-received) before placing them in the test apparatus. In those samples many surface cracks were formed. Figure 4-8 shows a dimple formed on a sample that had been preoxidized, rubbed with Cd and tested, ion milled, and examined. The Cd seemed to have reacted in patches (light gray areas in Figure 4-8a) and where the oxide surface film had cracked to form granules of Zr-Cd intermetallic compounds. There were many surface cracks in the metal associated with the intermetallics in the strained region (Figure 4-8b). Apparently Cd caused cracks to form after it had been rubbed into the Zircaloy surface, but not when it was simply placed on the surface. We presume that the small amounts of oxygen present during the tests were sufficient to form films that prevented reaction of Cd with Zr except when the Cd was forced into intimate contact with the Zr metal by abrasion. No further tests were made with Cd because its aggressiveness toward Zircaloy was not reproducible in the present type of test.

(a) DIMPLE IS NEAR CENTER OF PHOTOGRAPH

Sharp lines are oxide crack pattern etched into metal surface. Patches of light-gray in surrounding surface were Zr-Cd intermetallic. Width of photograph = 2 mm.

(b) DIMPLE CENTER

Metal cracks occurred at bottoms of oxide cracks where granular lumps of Zr-Cd intermetallic (light-gray lumps) formed. Width of photograph = 0.2 mm.

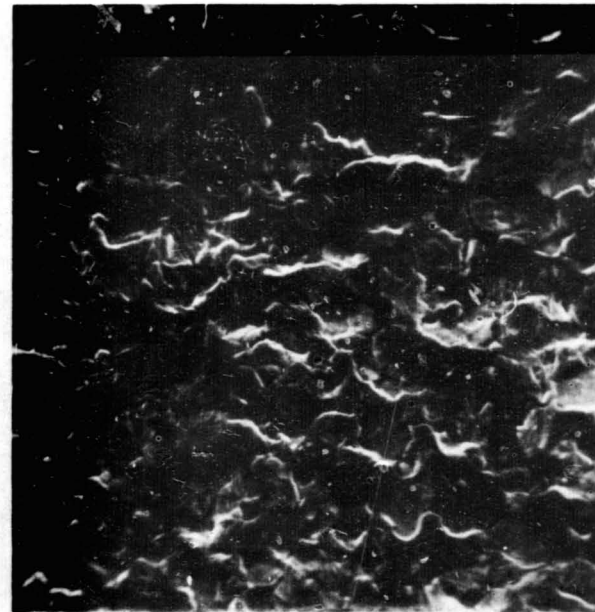
FIGURE 4-9 TYPICAL SMALL CRACKS IN ANNEALED ZIRCALLOY-2 TUBING

Figure 4-9 shows micrographs of typical dimple centers. The grain structure of this recrystallized material is clearly evident. Many of the grains show features that we believe were caused by coplanar slip with a vector inclined to the sample surface. Other grains are featureless, which may indicate that their basal planes

(and their close packed slip directions) were parallel to the surface and to the applied tensile stress. Typical examples of small cracks can be seen in the figure. Those cracks usually extended one or two grains in length and almost always occurred at the boundaries of the featureless grains. We suggest that this indicates that such boundaries are subjected to unusually high local stresses during plastic deformation.

The frequency of the small cracks in as-received samples was quantitatively found to increase slightly with increasing indenter load. However, as is evident from comparison of Figures 4-9a and 4-9b, the most noticeable effect of increasing the indenter load was to widen the cracks. Transgranular cracks were occasionally observed at large loads. The application time of the indenter load was not an important variable. Cracks occurred within the 5-minute period of the shortest test and the crack frequency for as-received samples was essentially independent of the time for which the indenter load was applied.

(b) AS IN (a) BUT WITH 70-kg LOAD
Width of photograph = 100 μ m.

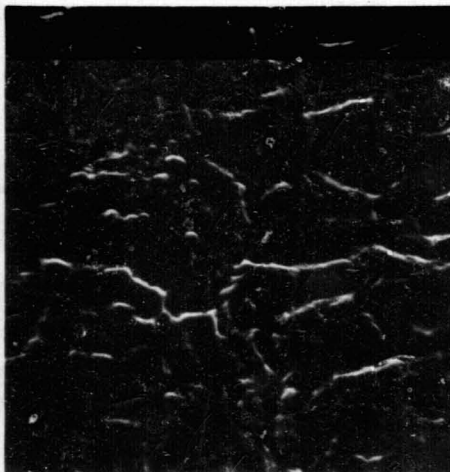
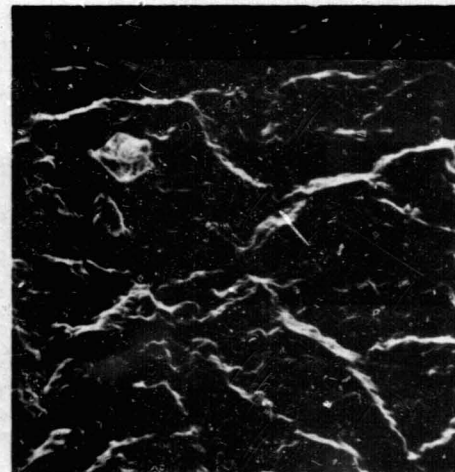
FIGURE 4-10 TYPICAL SMALL METAL CRACKS FORMED ON PREOXIDIZED ZIRCALLOY-2 SAMPLES

(a) ANNEALED ZIRCALLOY-2 WITH 0.2- μm OXIDE
40 Pa I_2 , 30-kg load, 30 min, 590 K, ion milled
60 min. The wrinkle marks are imprints of oxide
cracks. Small metal cracks are present but difficult
to discern. Width of photograph = 100 μm .

(b) ANNEALED ZIRCALLOY-2 WITH 1.5 μm OXIDE
40 Pa I_2 , 30-kg load, 30 min, 590 K, ion milled
150 min. Grooves are imprints of oxide cracks. A
metal crack runs approximately vertically through
the center. Granular lumps near center contain a
few percent Fe. Width of photograph = 50 μm .

(c) ANNEALED ZIRCALLOY-2 WITH 5- μm OXIDE
40 Pa I_2 , 30-kg load, 30 min, 590 K, ion milled
390 min. Grooves are imprints of oxide cracks.
Metal cracks are present but difficult to distin-
guish. Width of photograph = 100 μm .

$\sim 0.2 \mu\text{m}$ thick. The surface of the metal shows some wrinkles, which were the result of oxide cracks ion-milled into the metal surface. Small cracks are present in the metal grain boundaries. With a thicker oxide (about $1.5 \mu\text{m}$), the cracks in the metal generally were located at the bottom of oxide cracks, as shown in Figure 4-10b. The metal grain boundaries were difficult to see and it was hard to tell whether the cracks were intergranular or transgranular. Similar results were obtained with the thickest oxide studied (about $5 \mu\text{m}$ thick). Figure 4-10c shows the metal surface under a heavily oxidized specimen. The metal cracks were difficult to see so that only the larger cracks in the metal surface could be detected.

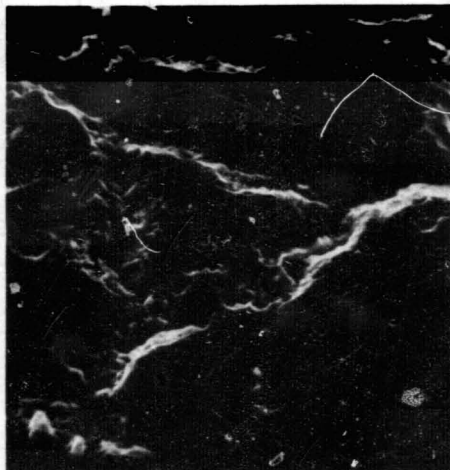
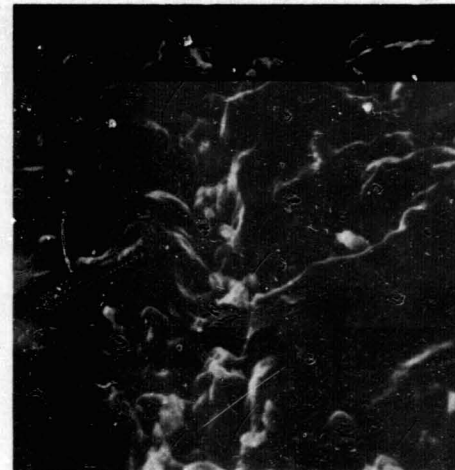
FIGURE 4-11 METAL CRACKS ASSOCIATED WITH IMPURITIES IN PREOXIDIZED SAMPLES OF ZIRCALLOY-2

Figure 4-11 shows examples of severe cracking. The granular material in the largest cracks contained iron and impurity elements and is clearly associated with the cracks. Iodine was observed frequently in that granular type of material, but never in the matrix metal. While examining some unstressed surfaces, we found evidence that the granular material formed only when iodine was present and only in regions that contained impurities or alloying additives at levels of a few percent or more. Figure 4-12 shows the growth of granules after exposure to iodine of a region surrounding an inclusion that was rich in Fe and Cr. The granules contained a few percent Fe. Inclusions rich in Fe and impurity elements were also frequently observed after ion milling of surfaces that had not been exposed to iodine.

(a) ANNEALED ZIRCALLOY-2 WITH 1.5 μm OXIDE
40 Pa I_2 , 70-kg load, 30 min, 590 K, ion milled
330 min. Severe metal cracks formed under oxide
cracks. The associated granular material contained
several percent Fe, and some Al, Sn, and Ti. Width
of photograph = 100 μm .

(b) ANNEALED ZIRCALLOY-2 WITH 5- μm OXIDE
40 Pa I_2 , 40-kg load, 30 min, 590 K, ion milled
330 min. The granular lumps associated with the
metal cracks contain a few percent Fe, Cr, and
Ti. Width of photograph = 100 μm .

(c) ANNEALED ZIRCALLOY-2 WITH 5- μm OXIDE
40 Pa I_2 , 40-kg load, 30 min, 590 K, ion milled
300 min. The granular lumps in the cracks con-
tained a few percent Fe, I, Cr, and Mn. The matrix
material was only Zr. Width of photograph = 50 μm .

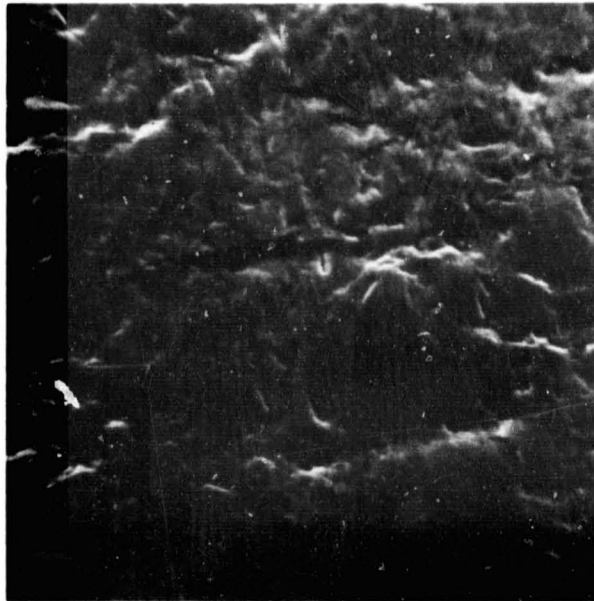
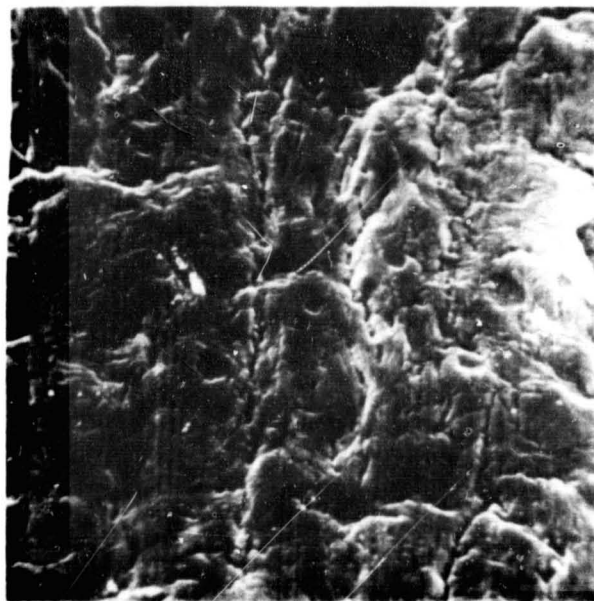
FIGURE 4-13 TYPICAL SMALL CRACKS IN STRESS-RELIEVED ZIRCALOY-4

Figure 4-13 shows the nature of the metal surface at a typical dimple after ion milling. Metal grains were not distinguishable in SEM photos of this material. There were two types of cracks--the small ones shown in Figure 4-13 and the larger ones shown in Figure 4-14. The frequency of the small cracks increased with iodine pressure and also seemed to increase somewhat with load and time under load. The large cracks (Figure 4-14) were again associated with local concentrations of additives or impurities. Because the presence of an impurity concentration in the dimple region was not a controllable parameter, the influence of test variables on the frequency of the large cracks could not be established.

(a) AS RECEIVED, 40 Pa I_2 , 40-kg LOAD, 1000 MIN, 630 K, ION
MILLED 45 MIN
Width of photograph = 100 μm .

(b) AS RECEIVED, 4 Pa I_2 , 50-kg LOAD, 30 MIN, 630 K, ION
MILLED 45 MIN
Width of photograph = 100 μm .

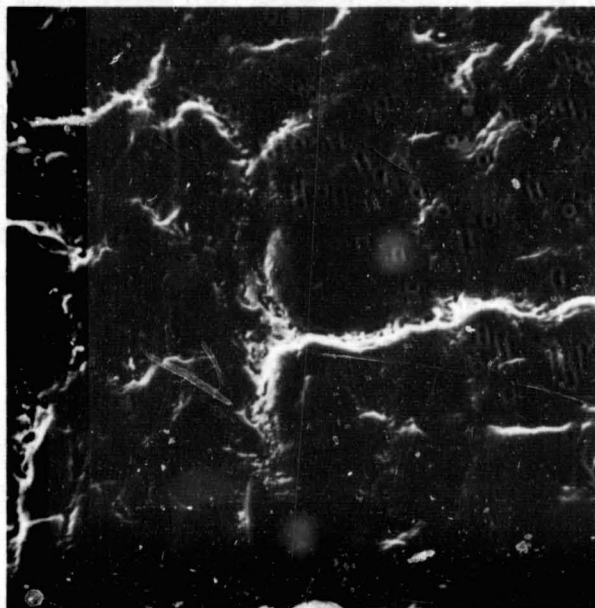
FIGURE 4-14 CRACKS ASSOCIATED WITH IMPURITIES IN ZIRCALOY-4

As received, 40 Pa I_2 , 50 kg load, 30 min, 630 K, ion milled 45 min. Granular material in the cracks is typical of Fe-rich material. Width of photograph = 100 μm .

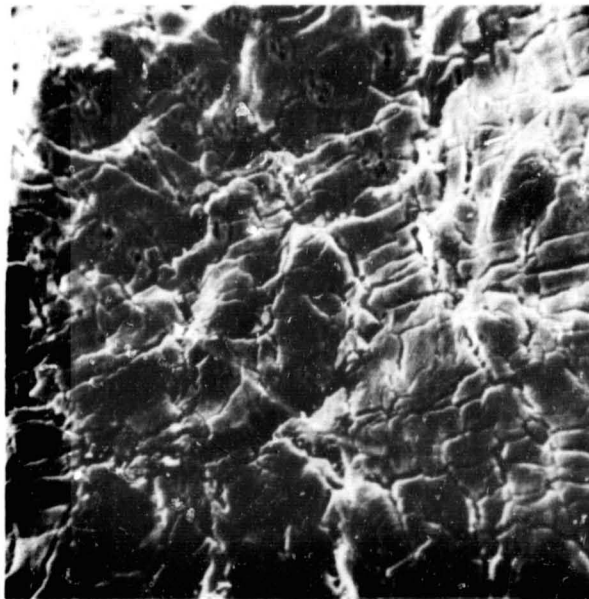
(a) **STRESS-RELIEVED ZIRCALOY-4, 0.2 μm OXIDE**
 40 Pa I_2 , 40-kg load, 30 min, ion milled 45 min. Small cracks possibly with some impurity. Width of photograph = 100 μm .

(b) **SAME AS (a) BUT WITH 50-kg LOAD**
 Large metal cracks associated with Fe-rich granules. Width of photograph = 100 μm .

FIGURE 4-15 METAL CRACKS IN PREOXIDIZED ZIRCALOY-4 TUBING SAMPLES

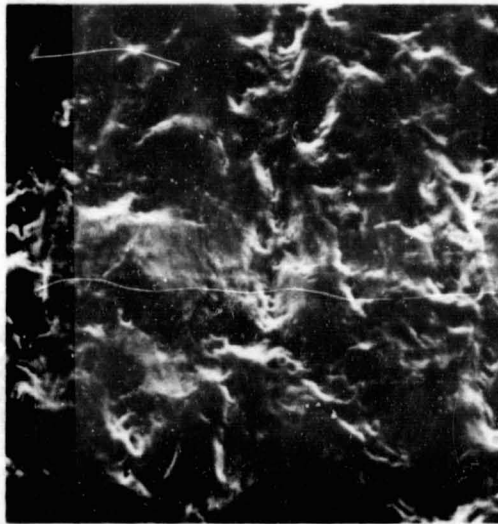
FIGURE 4-16 CORROSION PITS FORMED IN UNSTRESSED AREA OF ZIRCALOY-4 TUBING

Exposed to 4 Pa I_2 , 120 min, 630 K, ion milled 45 min. The white lumps in the pits contained a few percent Fe and some I. Before ion milling the whole surface was covered with a layer containing Fe, Al, and I and had mounds of corrosion product over the pits. Width of photograph = 50 μm .

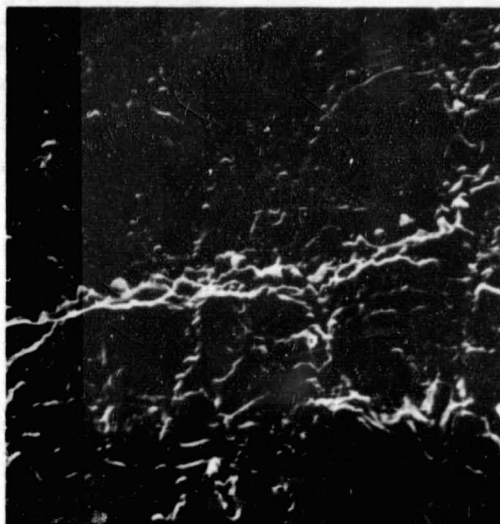
In this material, as in the others, two kinds of cracks appeared--small ones that were randomly distributed and occasional larger ones associated with concentration of impurities or alloying additives. No cracks were observed in the absence of iodine. Figure 4-17 shows a typical surface with small cracks. The frequency of these cracks increased with iodine pressure; increased load resulted in wider cracks with a slight increase in frequency. Figure 4-18 shows the surface of a preoxidized sample that contained some of the larger cracks. The association of these cracks with local concentrations of impurities and alloying additives is clearly apparent.

FIGURE 4-17 TYPICAL SURFACE OF STRESS-RELIEVED ZIRCALOY-2 SHOWING SMALL CRACKS

As received, 40 Pa I_2 , 100-kg load, 30 min, 590 K, ion milled 30 min.
Width of photograph = 100 μm .

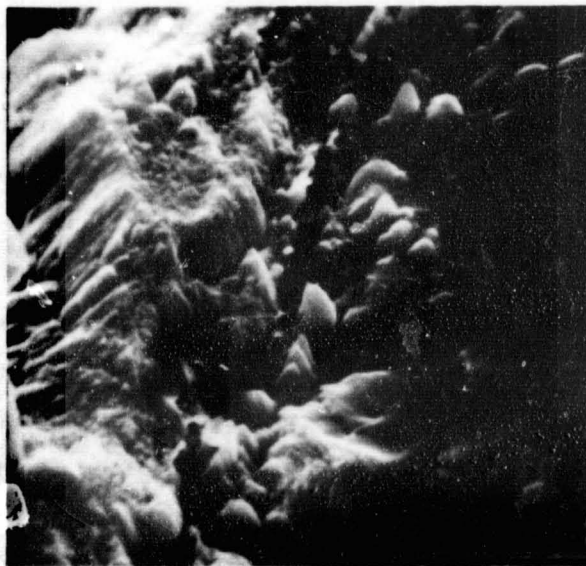
Two lengths of annealed Zircaloy-2 tubing (7AH11-S) were pressurized for 30 minutes at 590 K in the presence of iodine. The pressures were such that the nominal hoop stresses were 210 MPa and 310 MPa which are respectively below and above the threshold stress for iodine SCC of this tubing under internal pressurization (~ 280 MPa--see Section 5). After exposure, samples were cut out, and the inside surfaces were ion milled to remove corrosion products and then examined in the SEM. Small intergranular cracks similar to those shown in Figure 4-9 were observed in both samples. Larger cracks associated with local chemical inhomogeneities occurred at many sites in the sample stressed at 310 MPa, but were not observed in the sample stressed at 210 MPa. An example of a larger crack is shown in Figure 4-21. The crack is clearly associated with a local impurity concentration and follows along what appear to be the boundaries of the impurity-rich region. The crack in Figure 4-21 is indistinguishable in appearance from those observed in the indenter tests (see Figures 4-5 and 4-11). These results indicate that the larger cracks observed in the indenter experiments are capable of propagating and that the threshold stress for iodine SCC is associated with their formation.

(a) **SHOWING THE WAY THE CRACK FOLLOWS THE RIDGE OF SLOWLY MILLED MATERIAL**

Width of photograph = 45 μm .

(b) **A HIGHER MAGNIFICATION VIEW OF THE UPPER PART OF THE CRACK**

FIGURE 4-21 A LARGER CRACK OBSERVED IN AN ANNEALED ZIRCALOY-2 PRESSURE TEST SPECIMEN STRESSED AT 310 MPa IN THE PRESENCE OF IODINE

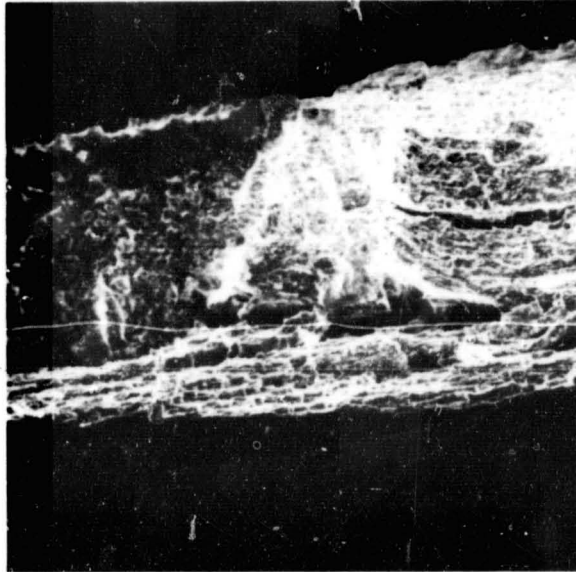
Two types of SCC failures were observed in the preflawed specimens Zr-4-14 through Zr-4-23. The majority of specimens showed pinhole failures (termed SCC-1 in Table 5-1), but two showed short axial splits (SCC-2 in Table 5-1). Optical metallography (Figure 5-7) and SEM fractography (Figure 5-8) showed well-defined axially oriented SCC regions (usually approximately semielliptical in shape) emanating from the preflaws and terminating in a ductile tear or blowout, but revealed no explanation for the two types of final failure. The higher magnification fractograph in Figure 5-8b shows the brittle nature of the SCC microfracture process (compare with Figure 5-6b). The fracture path appears to be transgranular, but the well-defined cleavage and fluting features reported by others (5-3) are not apparent. Most of the fracture surfaces and all of the inside surfaces of the tubes were oxide covered, probably due to the posttest hydrolysis of iodide films formed during the test. The inside surfaces of the specimens showed evidence of pitting attack, and elemental analysis

FIGURE 5-7 OPTICAL FRACTOGRAPH OF SPECIMEN Zr-4-18 SHOWING A WELL-DEFINED REGION OF SCC THAT PENETRATED ALMOST COMPLETELY THROUGH THE TUBING WALL

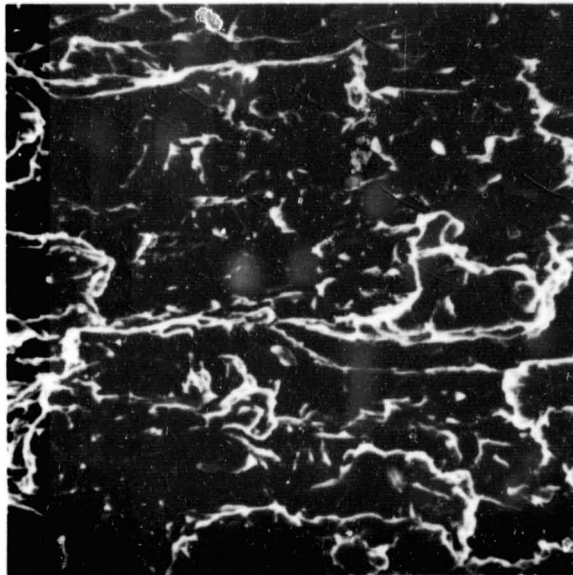
(a) GENERAL VIEW AT 100x SHOWING THE TUBE I.D., PART OF THE PREFLOW, THE SCC REGION, AND THE BLOWOUT REGION ASSOCIATED WITH THE FINAL PINHOLE FAILURE. NOTE THE PITTING OF THE TUBE I.D.

(b) TYPICAL AREA IN THE SCC REGION (1000X)

FIGURE 5-8 SEM FRACTOGRAPHS OF SPECIMEN Zr-4-14 PRESSURIZED TO FAILURE AT 630 K IN THE PRESENCE OF IODINE

indicated that the presence of iron on both the inside surfaces and fracture surfaces. We presume that this iron originated in the stainless steel pressure tubing and fittings and was transported to the specimen via an iodide vapor, probably FeI_2 .

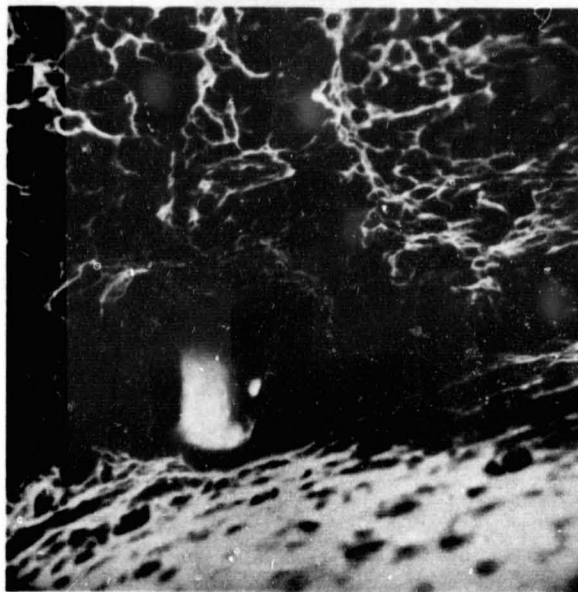
Optical metallography of cross sections through several fracture surfaces indicated the features typified by Figure 5-9. The SCC regions generally were approximately parallel to the radial direction (i.e., perpendicular to the hoop stress), whereas the ductile overload parts of the fracture surfaces usually were inclined at about 45° to the radial direction. The SCC cracks were more branched and penetrated a shorter distance through the cladding wall in specimens tested at higher stresses.

FIGURE 5-9 CROSS SECTION THROUGH THE FRACTURE SURFACE OF SPECIMEN Zr-4-17 (7FD11 ZIRCALOY-4)

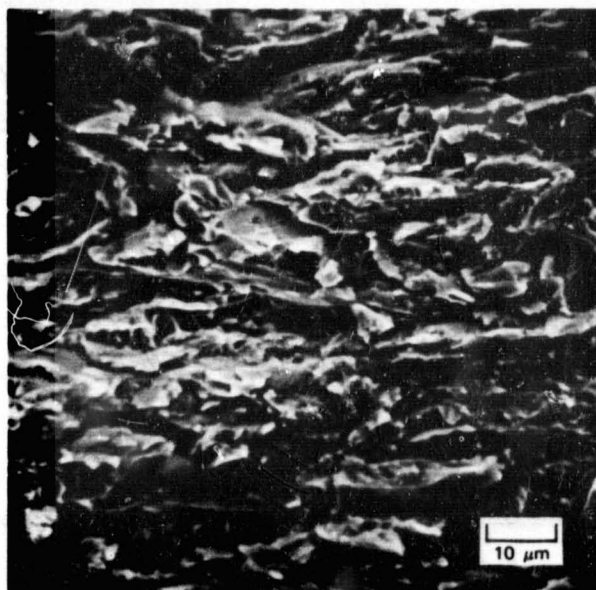
seals in specimen HBR-3 was found to be better preserved, perhaps because that region was partially protected from the test environment. Figure 5-11 is a typical view of one of the failures in specimen HBR-3 and shows the mixture of the transgranular cleavage and plastic tearing that is often associated with iodine SCC of Zircalloys (5-3). Note that the appearance of the fracture surface in Figure 5-11 is similar (although better preserved) to that of the unirradiated specimen in Figure 5-8b.

FIGURE 5-11 FRACTURE SURFACE OF SPECIMEN HBR-3 (IRRADIATED ZIRCALOY-4 CLADDING) TESTED IN THE PRESENCE OF IODINE AT 630 K

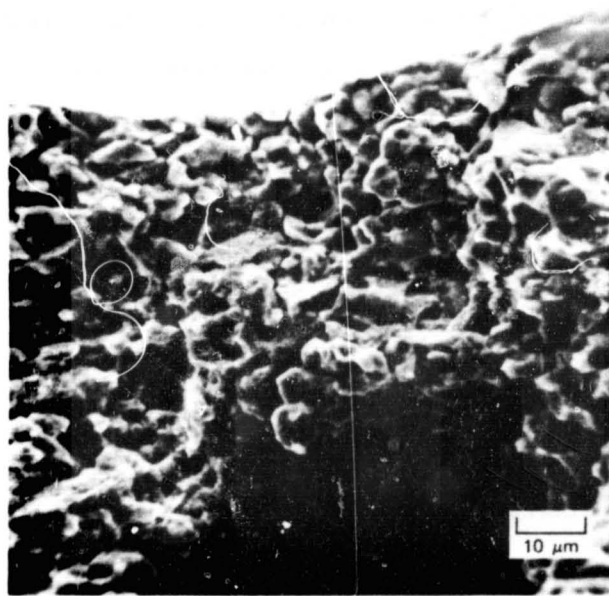
The two modes of SCC failure noted for the other test materials were also observed in 7AH11-S Zircaloy-2. Although the fine details of the fracture surfaces were generally obscured by corrosion products, SEM examination indicated that the SCC regions did not penetrate very far through the cladding wall in these specimens and contained more features suggestive of intergranular crack growth than the SCC regions in 7FD11 or 7AH11-H specimens. For example, Figure 5-12 shows the part of the SCC region adjacent to the inside surface in specimen Zr-2S-16. The appearance of this fracture is quite different from that of the stress-relieved Zircaloy-4 specimen shown in Figure 5-8.

FIGURE 5-12 FRACTURE SURFACE OF SPECIMEN Zr-2S-16 (UNIRRADIATED ZIRCALOY-2) TESTED IN THE PRESENCE OF IODINE AT 590 K

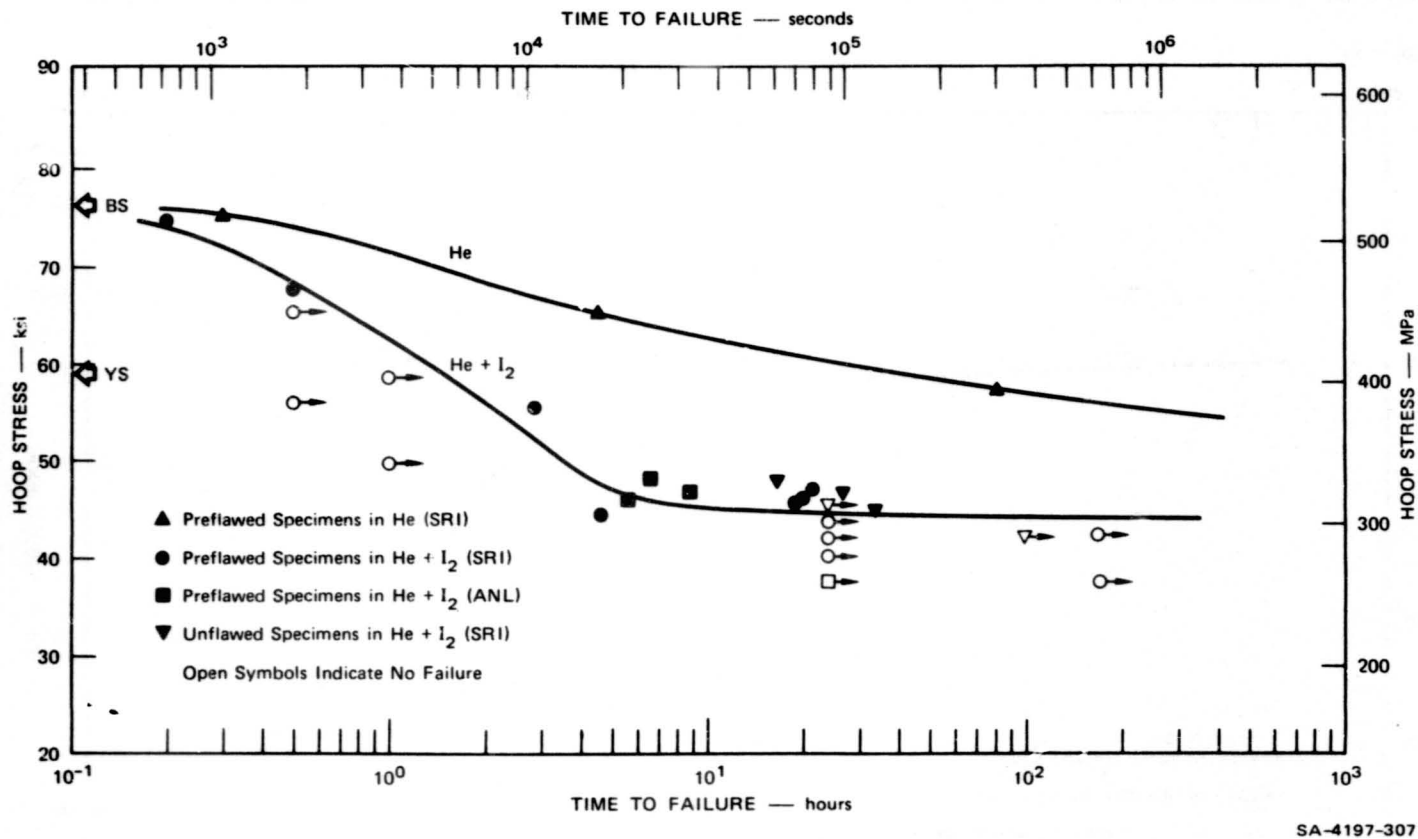
Although the data exhibit some scatter, Figure 5-13 shows that a well-defined threshold for iodine SCC of 7FD11 Zircaloy-4 at 630 K exists at a hoop stress of about 300 MPa. At stresses just above this threshold, exposure to iodine results in failure in much shorter times than those required for creep-rupture failure in an inert environment. At higher stresses, the iodine SCC and creep rupture failure curves converge, and at stresses close to the burst stress (~ 525 MPa), the failure times are similar. As indicated in Table 5-1, the decreased failure time in iodine environments is accompanied by a decrease of failure strain of up to a factor of 10 for both preflawed and unflawed test specimens.

FIGURE 5-13 RESULTS OF TUBE PRESSURIZATION TESTS ON 7FD11 ZIRCALOY-4 SPECIMENS AT 630 K

The He + I₂ curve approximately defines the minimum conditions required for iodine-induced failure and may be somewhat conservative because of the scatter in the data.

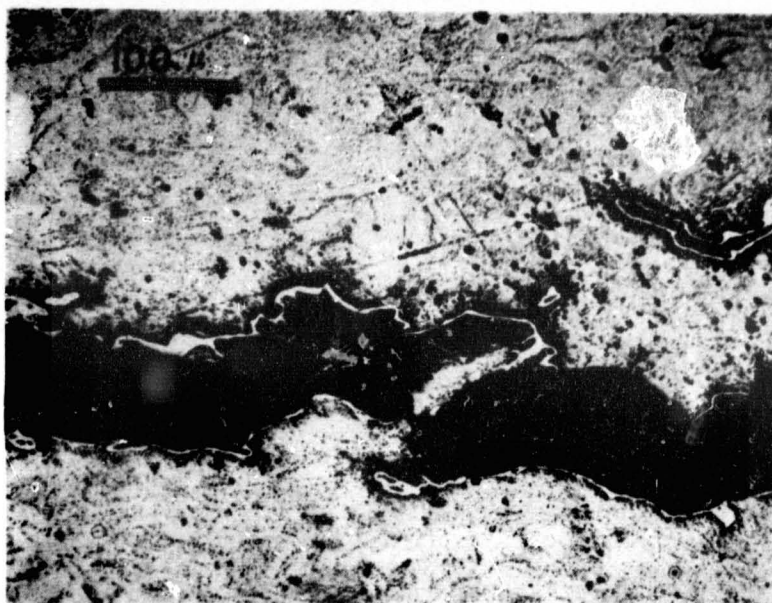
Fractographic observations did not completely clarify the nature of the rate controlling process, but they did demonstrate that hydride formation is involved in hydrogen-induced slow crack growth. Figure 6-6 shows that the process is very crystallographic with many cleaved facets and unidirectional slabs of zirconium hydride on the fracture surface. Moreover, the cross section in Figure 6-7 shows that the entire fracture surface was covered with a $10\text{-}\mu\text{m}$ -thick layer, which was identified as ZrH by x-ray diffraction.

FIGURE 6-6 FRACTURE SURFACE OF ANNEALED ZIRCALOY-4
PLATE FOLLOWING SLOW CRACK GROWTH IN
HYDROGEN AT 297 K AND A PRESSURE OF ~86 kPa

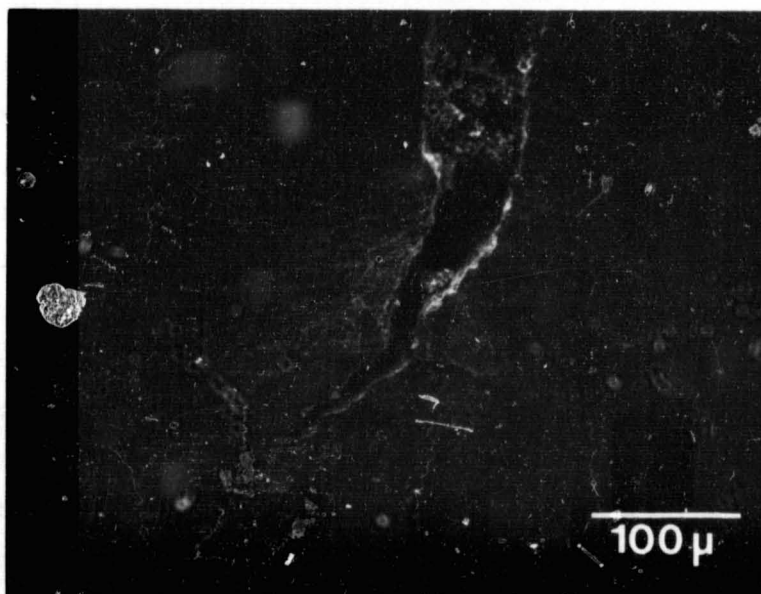
FIGURE 6-19 A 4-POINT BEND SPECIMEN OF STRESS-RELIEVED ZIRCALOY-4 AFTER FAILURE IN CADMIUM AT 633 K

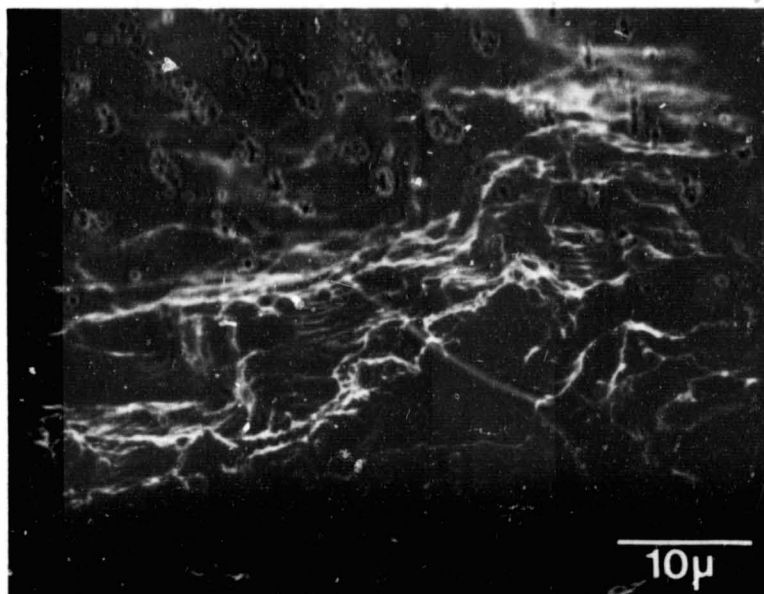
FIGURE 6-21 A PLASTICALLY DEFORMED BRIDGE IN A 4-POINT BEND SPECIMEN OF STRESS-RELIEVED ZIRCALOY-4 AFTER FAILURE IN THE ELASTIC REGION IN CADMIUM AT 633 K
